FULL RESERVE STUDY

EAST BAYSIDE CONDOMINIUM ASSOCIATION

145 PLEASANT STREET

Site Inspections June 15, 2017

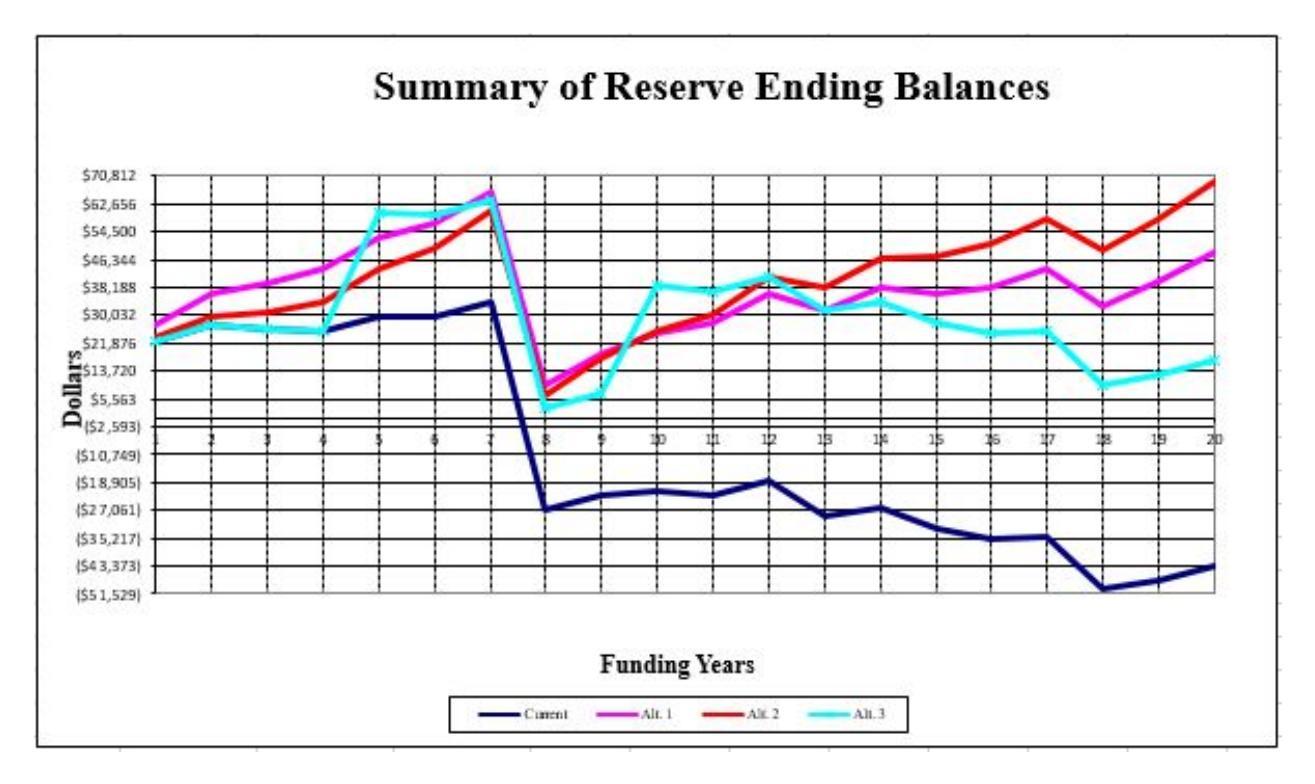
Figure 1: Summary of Ending Balances

In the summary, the 20-year total of projected capital expenditure (CapEx) budgets, (current dollar cost estimates inflated at 3% annually), is \$174,692. The Board has provided us with information on the Association's Capital Reserve Fund and the current funding plan. Our initial financial analysis was based on the data supplied. Given the reported starting balance of the Capital Reserve Fund on June 15, 2017, the current ongoing rate of contribution \$5,000/year, and an anticipated average rate of return on investment of 0% per year, our financial analysis indicates that the Association's current funding will prove **INADEQUATE** to meet future needs. Because of draw-downs to pay for projected CapEx expenses, projected year-end fund balances are (\$43,532) by the end of the 20-year planning period in 2036. In this report, we have recommended minimum threshold fund balances be maintained and have included alternate funding plans as discussed with the Board. Please see Table 1.0 and 2.0, below, for a summary of assumptions and projections along with 3 scenarios for improving the funding situation. These scenarios are depicted in Figure 1.
